## CORKSPORT MOTOR MOUNT INSERTS 2007-2010+ MAZDASPEED3

<b>PART NUMBER:</b> AXL-6-126	<b>MODEL:</b> MAZDASPEED3	<b>YEAR:</b> 2007-2010+	<b>TRIM:</b> ALL
<b>TIME ESTIMATE:</b> 20-40 MIN.			
<b>WRENCH RATING:</b> 2/5

# INSTALLATION INSTRUCTIONS: CORKSPORT MOTOR MOUNT INSERTS 2007-2010+ MAZDASPEED 3

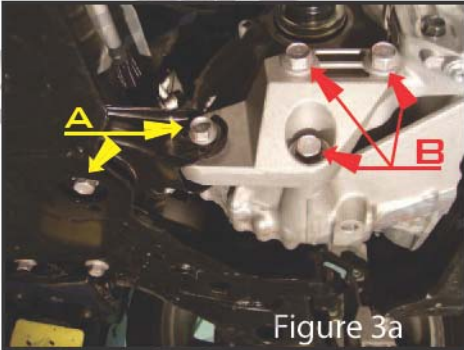
Figure 3a

WE'LL BE WORKING UNDER THE CAR AT THE REAR OF THE ENGINE FOR THIS JOB, DIRECTLY BEHIND THE BACK EDGE OF THE ENGINE UNDERTRAY. UNBOLT THE TWO 17MM HEX HEAD MOTOR MOUNT FASTENERS SHOWN IN **FIGURE 2**, A. (PLACE THEM IN A LOCATION WHERE YOU CAN IDENTIFY WHICH IS WHICH, THEY ARE DIFFERENT - IF YOU GET CONFUSED, THE ONE WITH THE LARGER SHANK IS THE VERTICAL BOLT).

REMOVE THREE 17MM HEX HEAD BOLTS FROM ATTACHMENT BRACKET (B ON **FIGURE 2**) AND REMOVE THE BRACKET. REMOVE THE MOTOR MOUNT, IT SHOULD COME OUT WITH VERY LITTLE EFFORT WHEN THE BRACKET IS NOT OBSTRUCTING IT'S WAY.

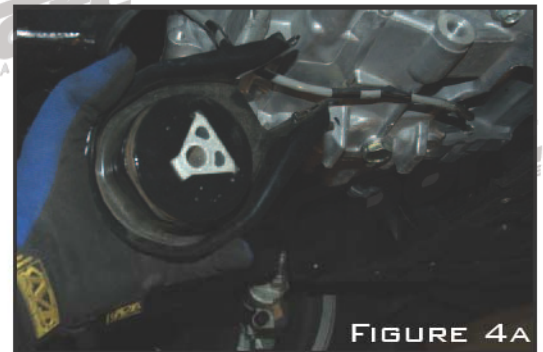
FIGURE 4A

THE INSERTS ARE UNIDIRECTIONAL, THE TWO SIDES OF THE MOUNT ARE DIFFERENT AND EACH INSERT ONLY FITS ONE SIDE. THE SMALLER DIAMETER GOES ON THE TOP (SEE **FIGURE 4A**) LARGER DIAMETER INSERT GOES ON THE BOTTOM (SEE **FIGURE 4B**).
